Re: FAA
Buffalo Niagara International Airport
Airport Master Plan Update/CHEEKTOWAGA,
Erie County
10PR05280

SUBJECT: Buffalo Niagara International Airport
Wetland Verification Site Visit

BUFFALO NIAGARA INTERNATIONAL AIRPORT WETLAND PHOTO LOGUE for 2010

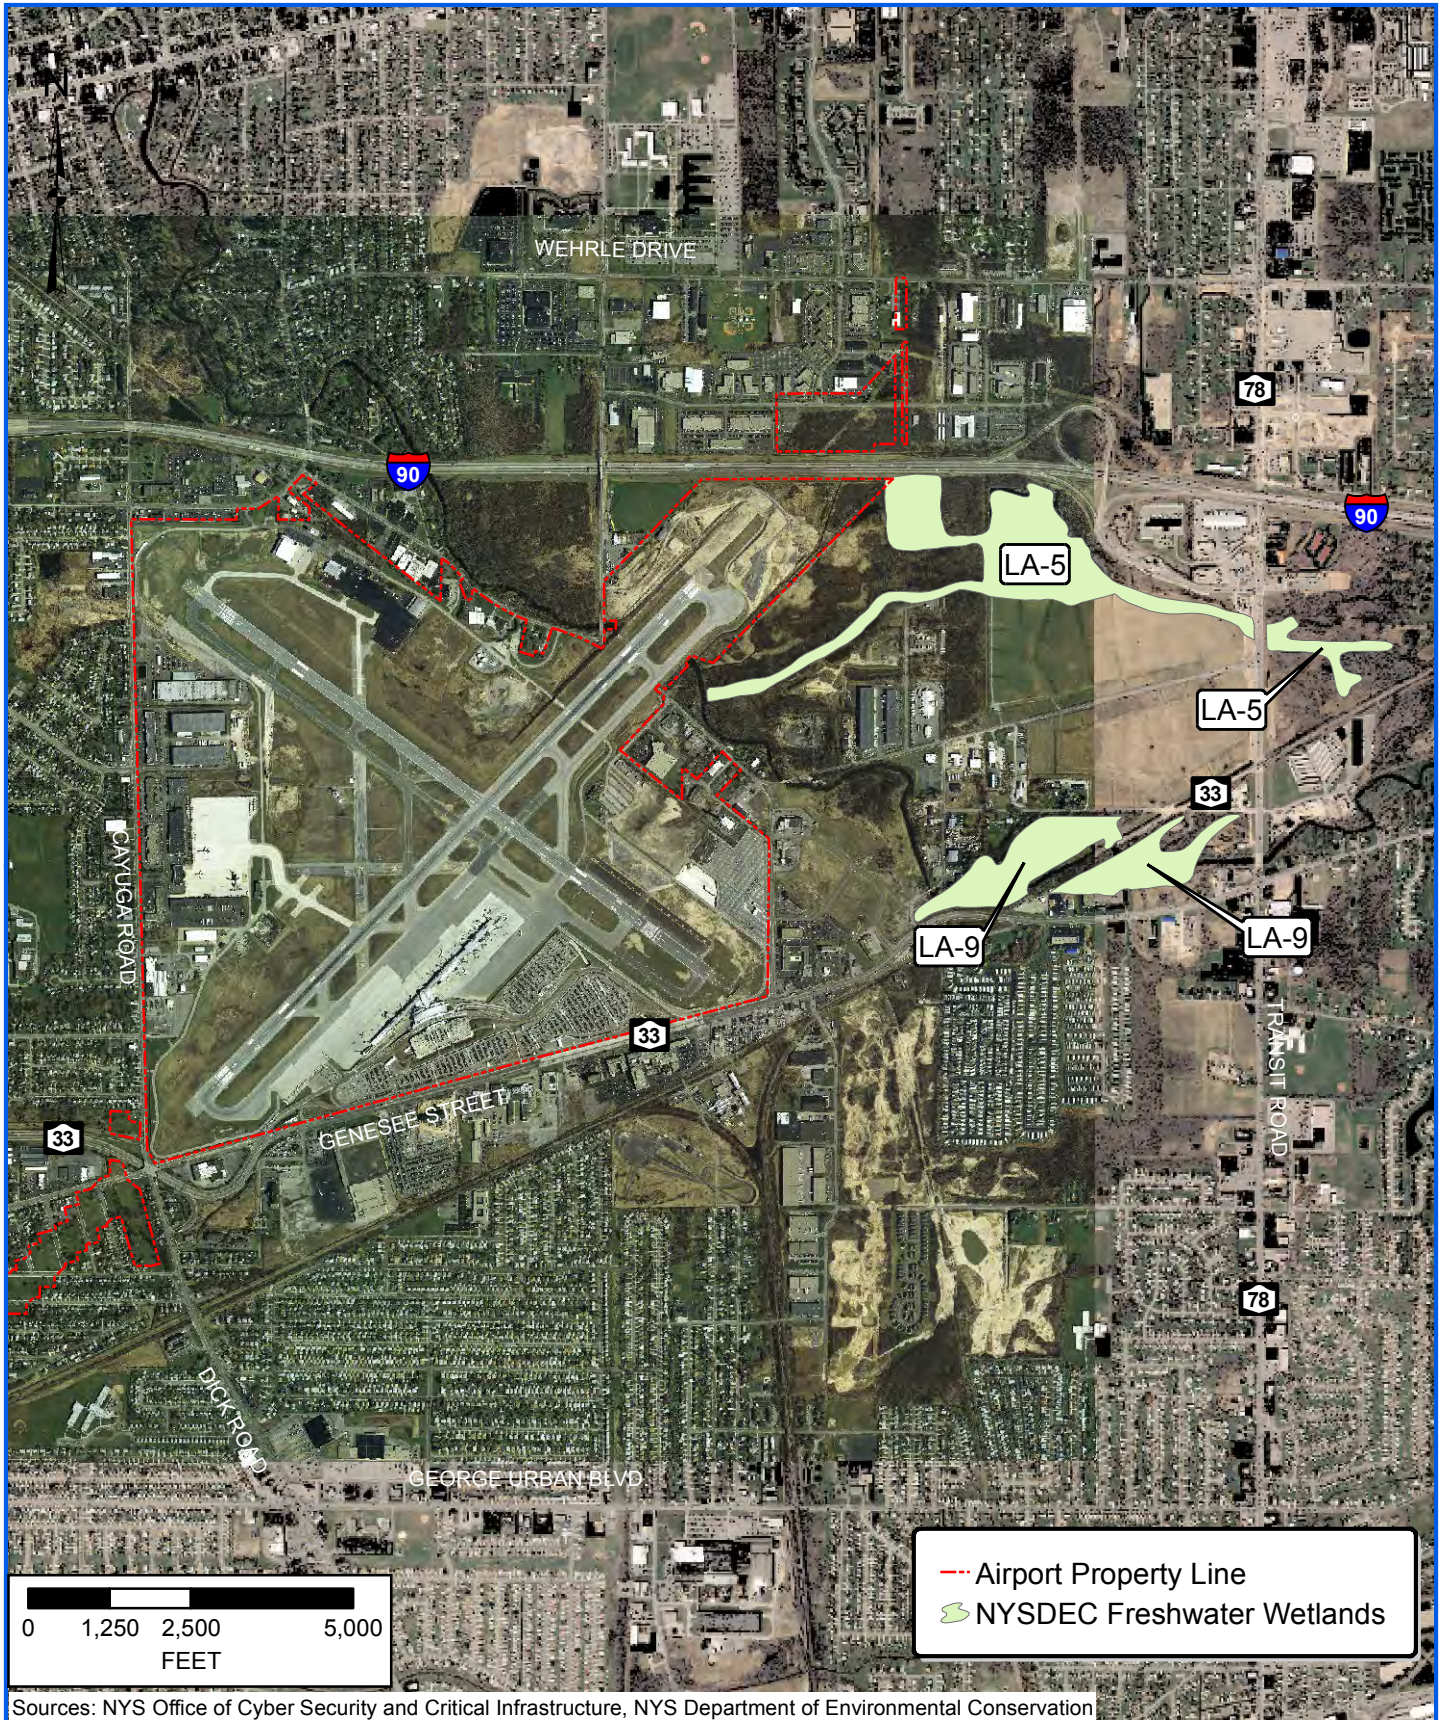
Figure 3 *NYSDEC Wetlands* shows no state regulated wetlands on the BNIA property. An area identified as L-5 is the closest state regulated wetland area to the airport. It is located to the east of the Runway 23 end. L-5 surrounds Aero Lake. The wetland's associated state regulated wetland checkzone surrounds L-5 and also follows the lake's drainage channel that to its outlet at Ellicott Creek. The checkzone is a mapped sector where the wetland border has yet to be determined by a delineation. The NYSDEC Resource Mapper image shows the checkzone terminating at the south side of the Runway 23 end. This wetland complex is a state Class I wetland consisting of approximately 81.4 acres. The wetlands recorded on these maps were confirmed by visual observations of the area.

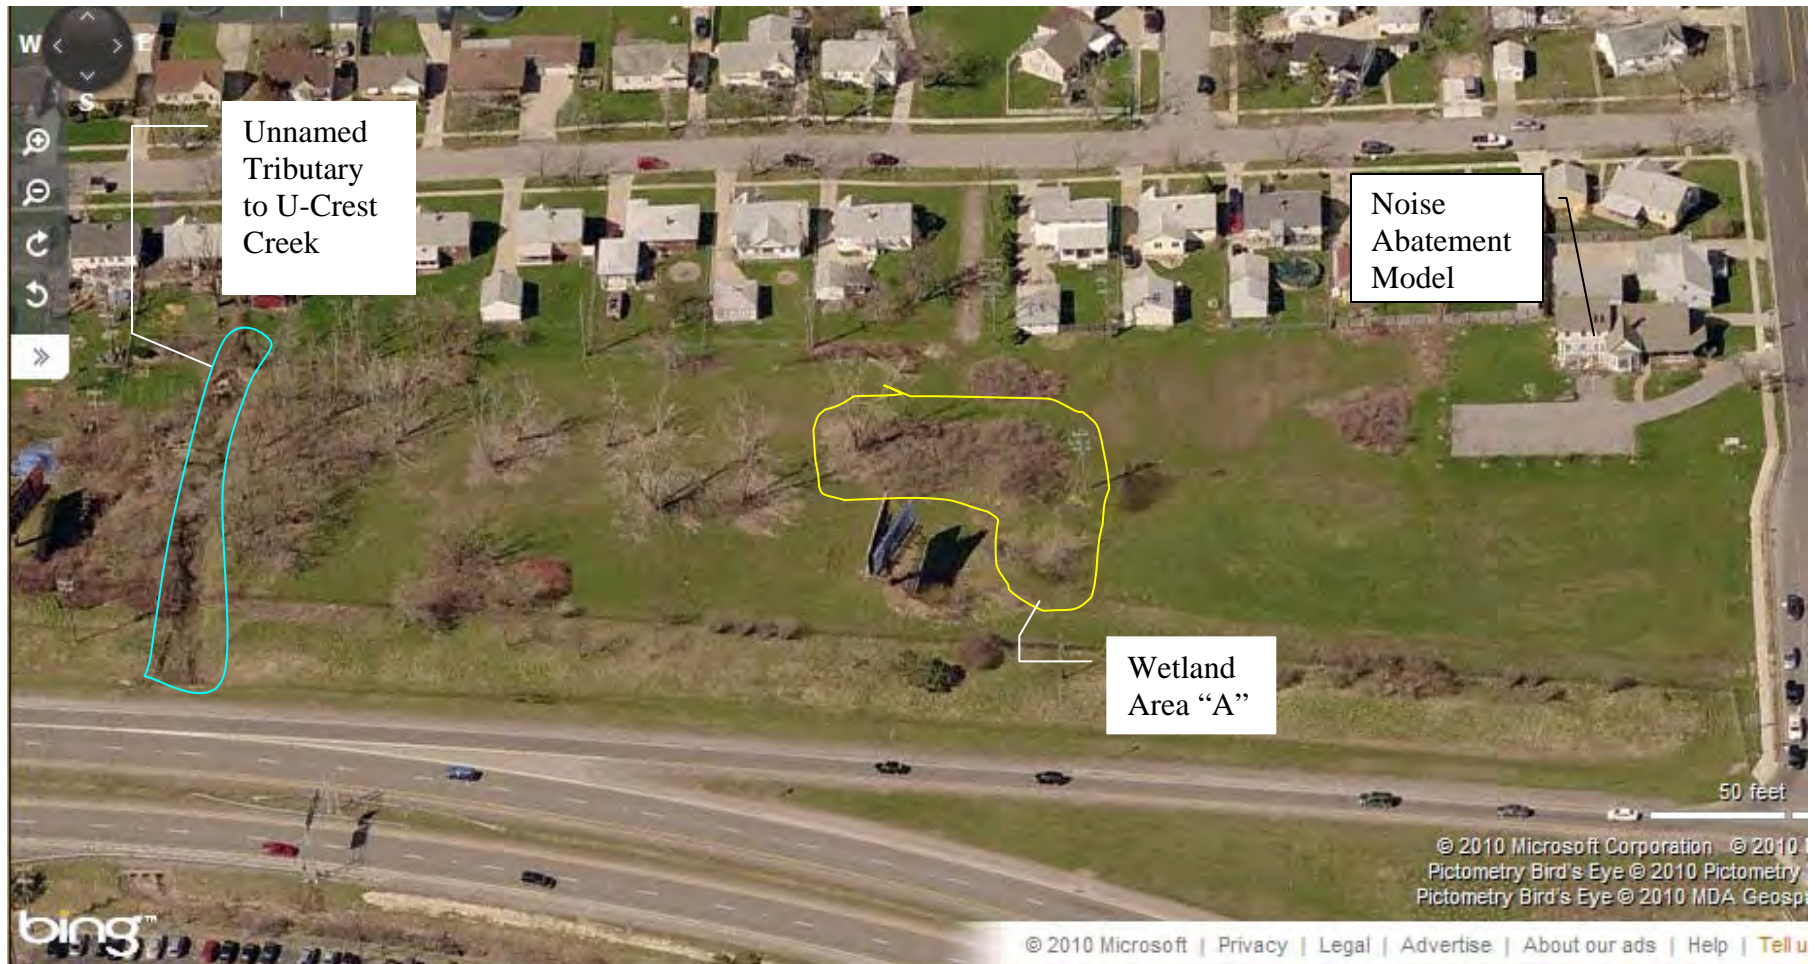
Wetland Area "A": Intersection of Kensington Expressway and Cayuga Street.

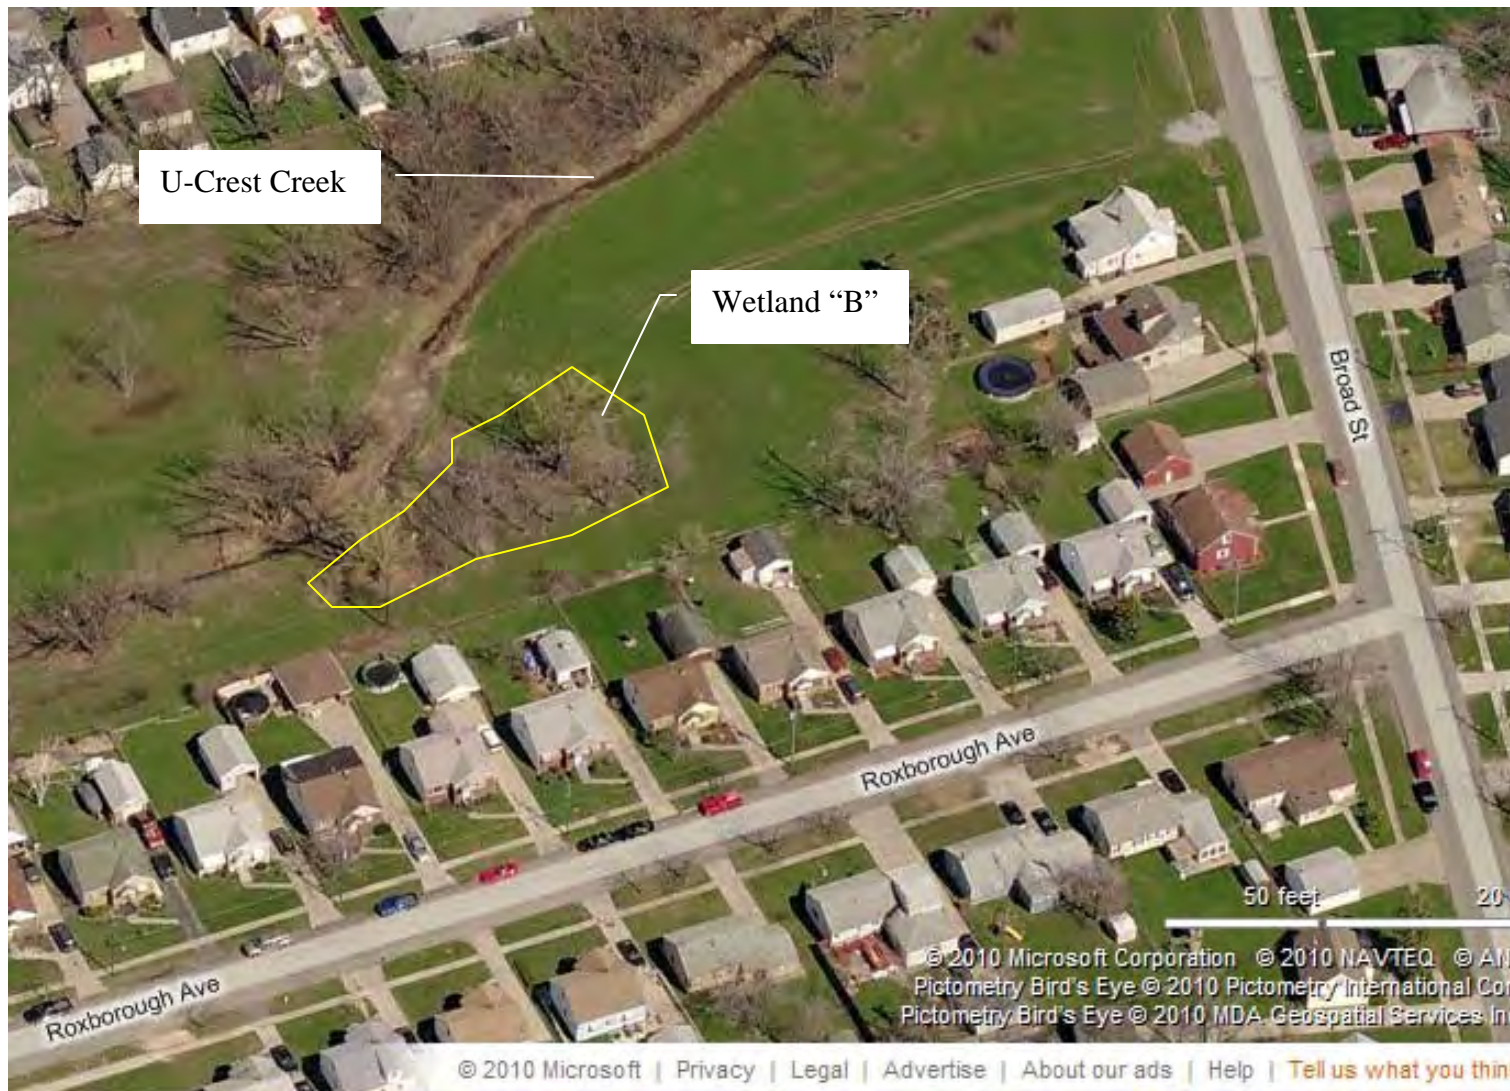
Wetland Area "B" near U-Crest Creek.

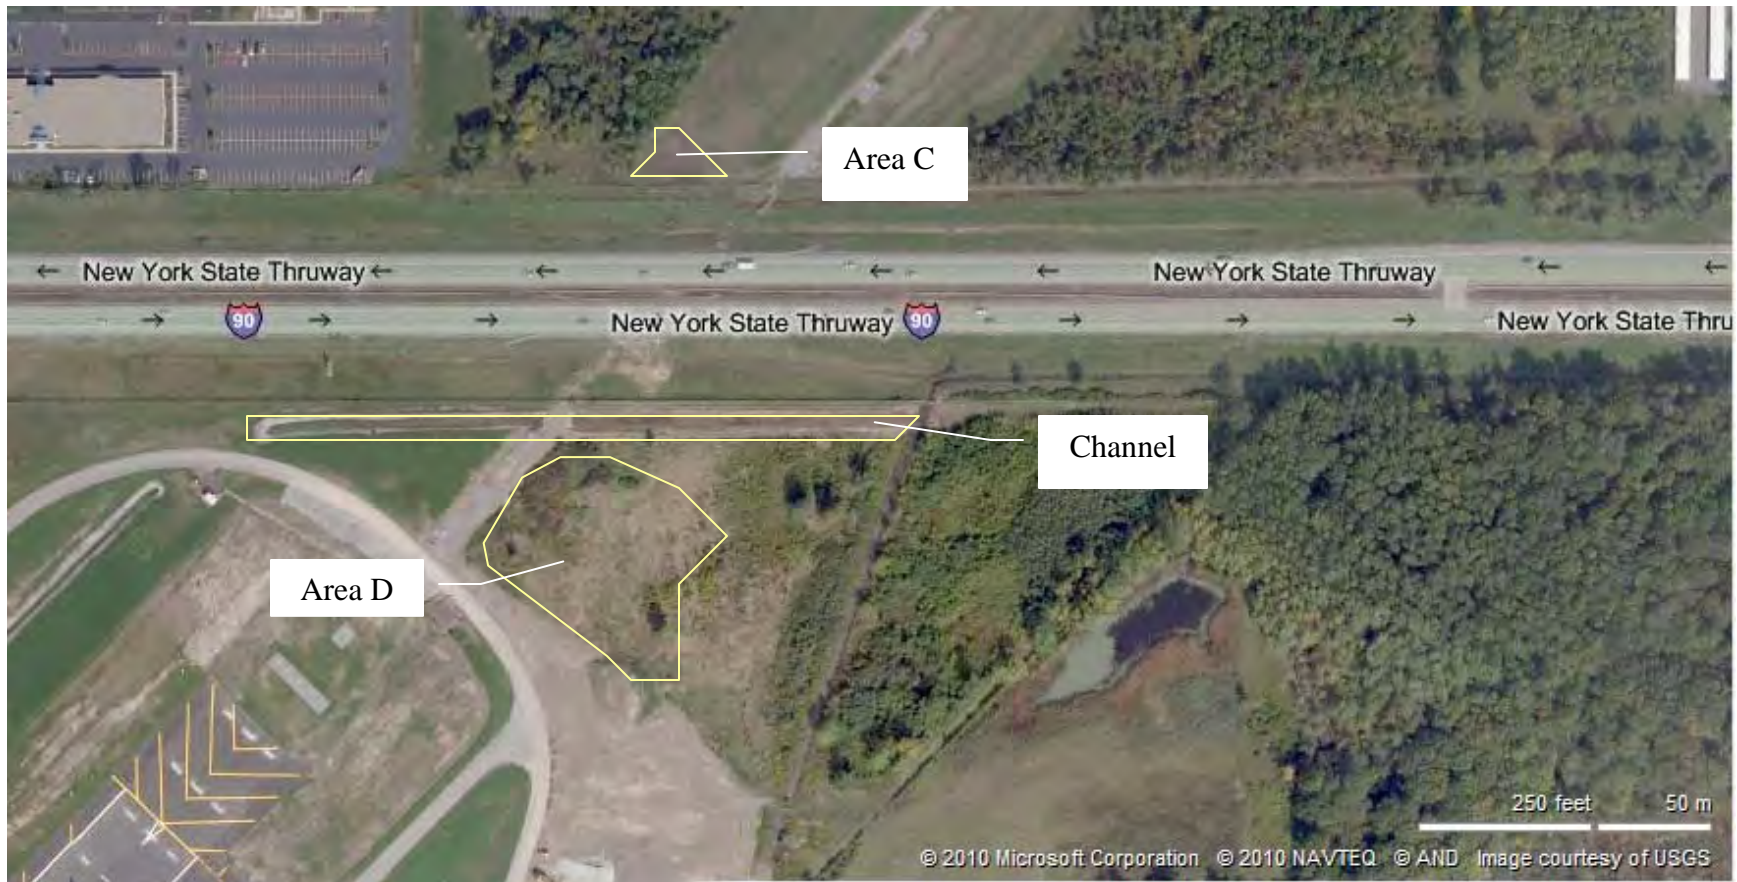
Wetland Areas C, D and the drainage channel.

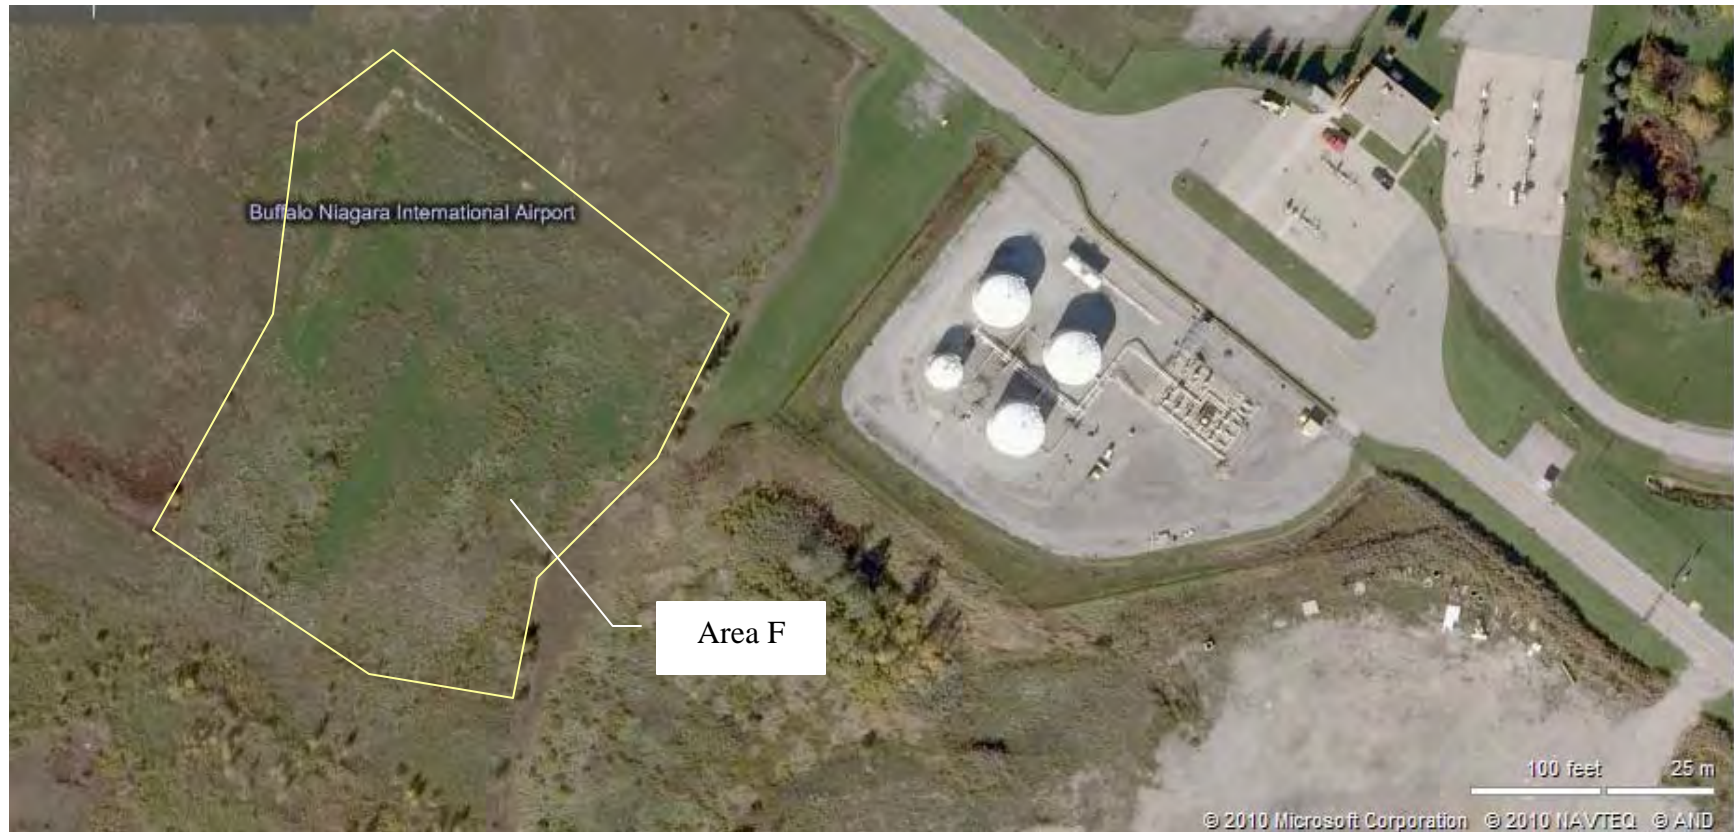
Wetland Area F adjacent to the Fuel Farm area off of the airport's perimeter road.

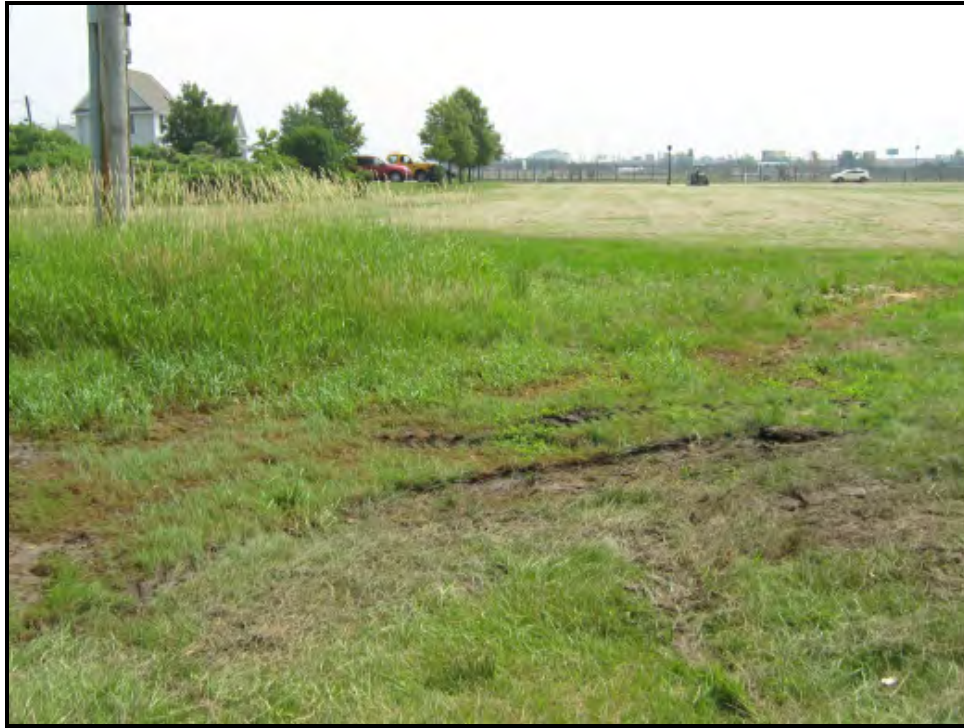
Photograph 1: Wetland Area "A" northwest of intersection of Kensington Expressway and Cayuga Road looking toward Runway 5 end. (MJ Photo 07/06/10)

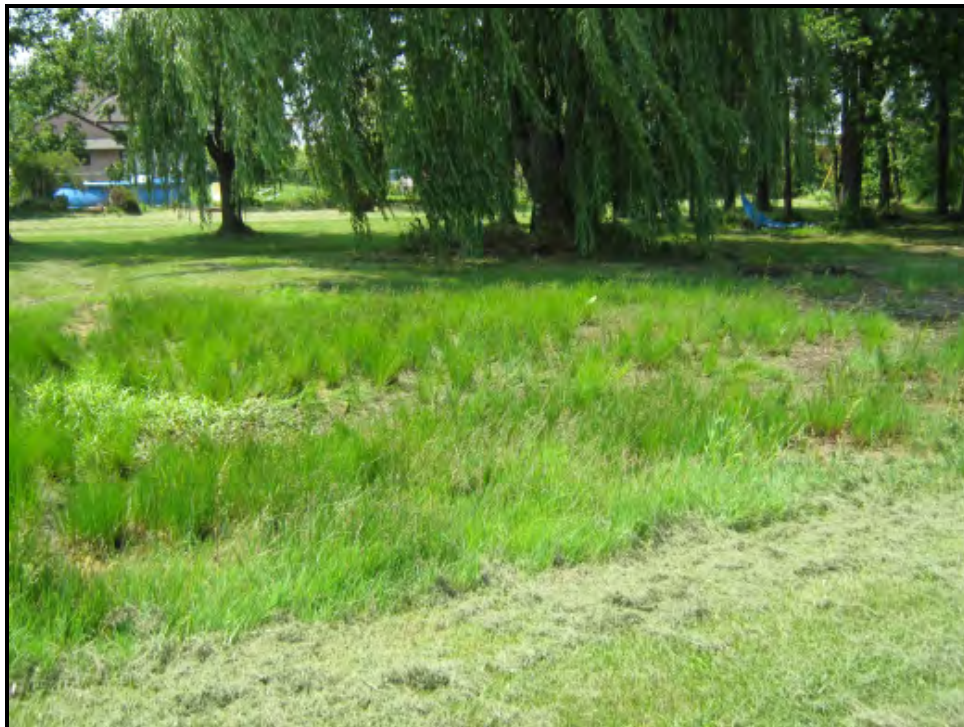
Photograph 2: Wetland Area "B" situated within the Runway 5 MALSR area south of houses along Genesee Street. (MJ Photo 07/06/10)

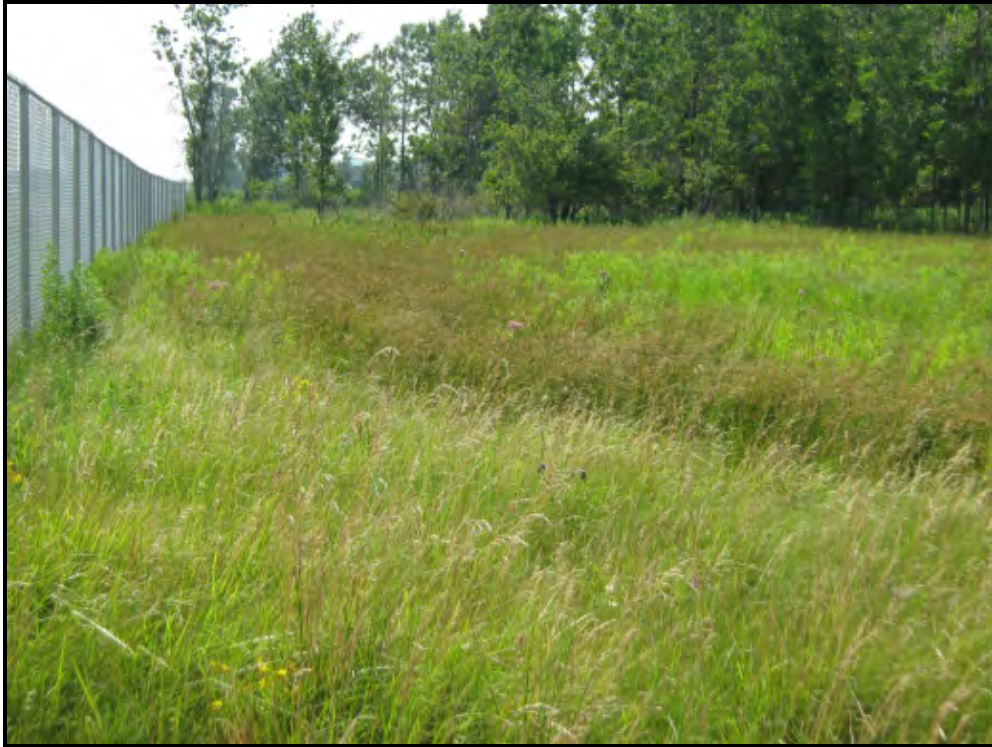
Photograph 3: Wetland Area "C" on the north side of the NYS Thruway Route 90 westbound fence along the Runway 23 MALS light area. (MJ Photo 07/06/10)

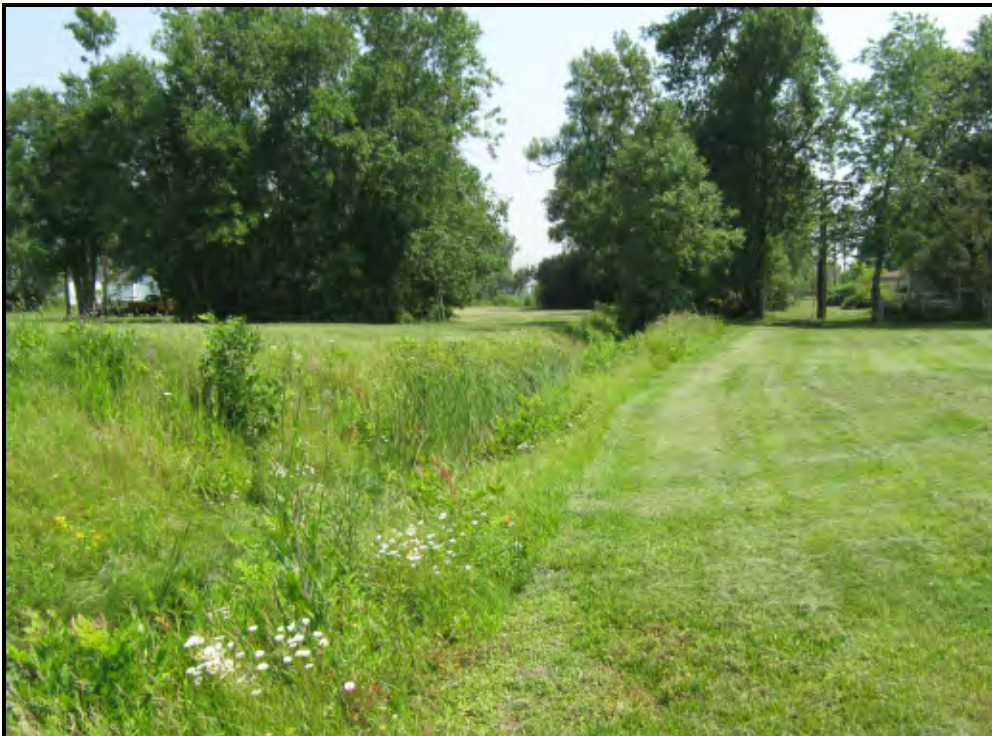
Photograph 4: Northern reach of U-Crest Creek near the Genesee Street culvert. (MJ Photo 07/06/10)

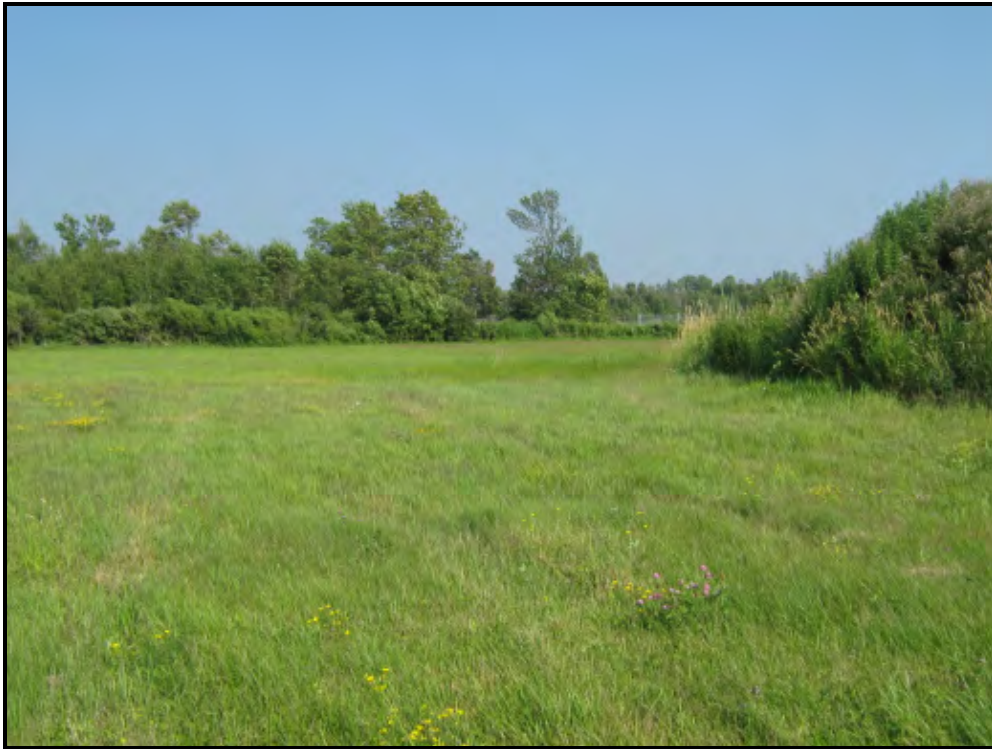
Photograph 5: Wetland Area “D” off of Runway 23 (PEM) looking to the southeast. An excavated drainage channel flows through the far tree line. The mound is an excavated pile that is below the elevation of the end of Runway 23 to the southwest. (MJ Photo 07/06/10)

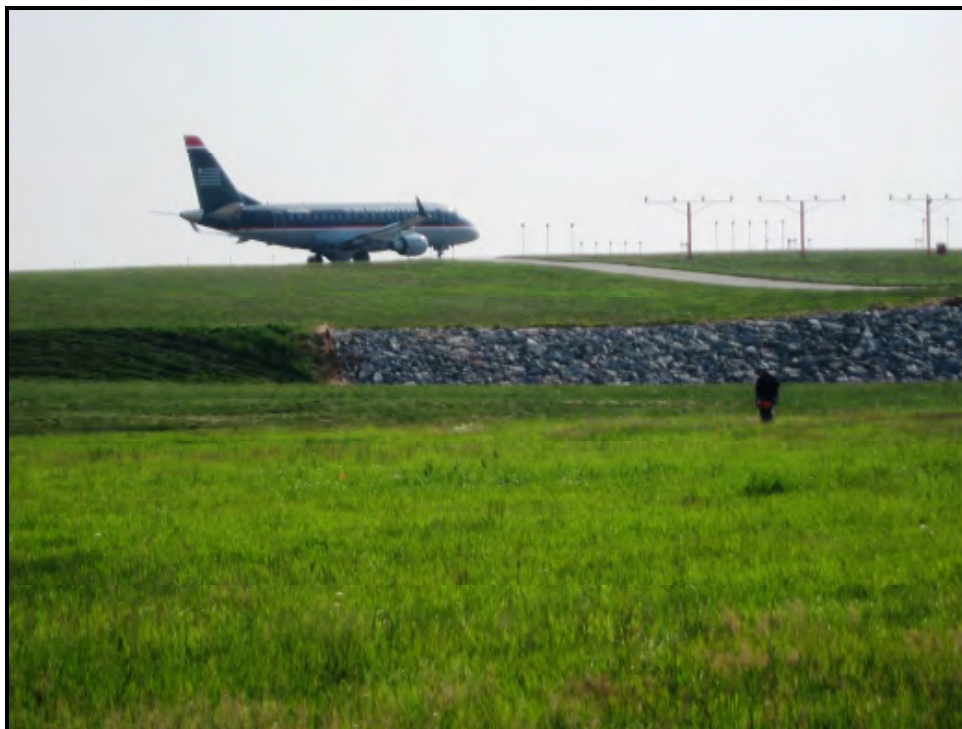
Photograph 6: Wetland Area “D” beyond Runway 23 end looking southwest toward the runway end.

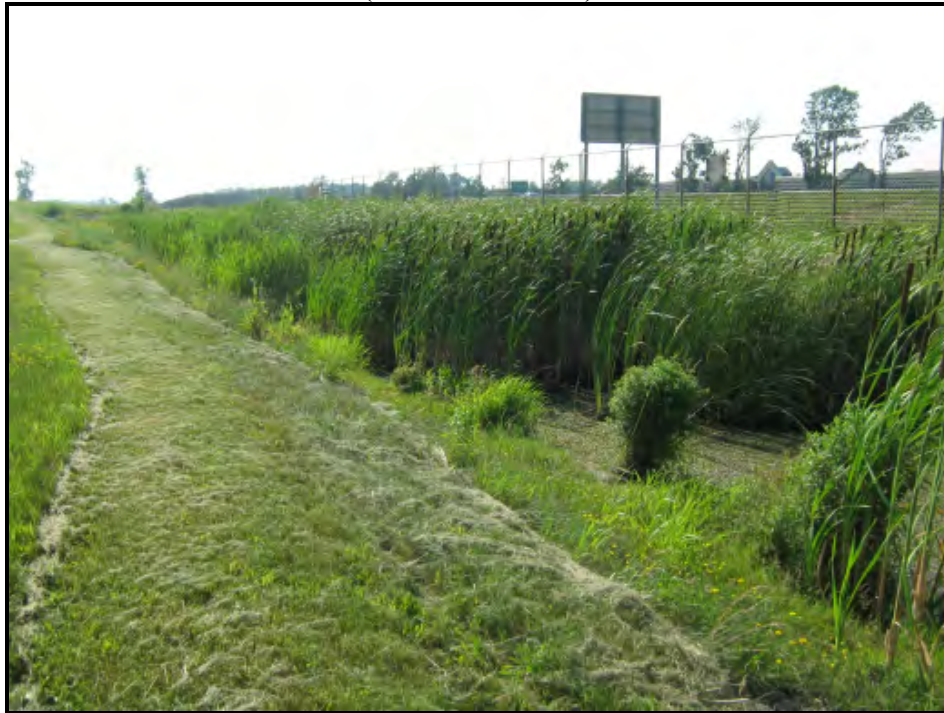
Photograph 7: Drainage channel outside of the NYS Thruway eastbound right-of-way fence. Channel is along the north edge of the wetland on the Runway 23 end, but is divided by the mowed berm pictured along the left side of this photograph. (MJ Photo 07/06/10)

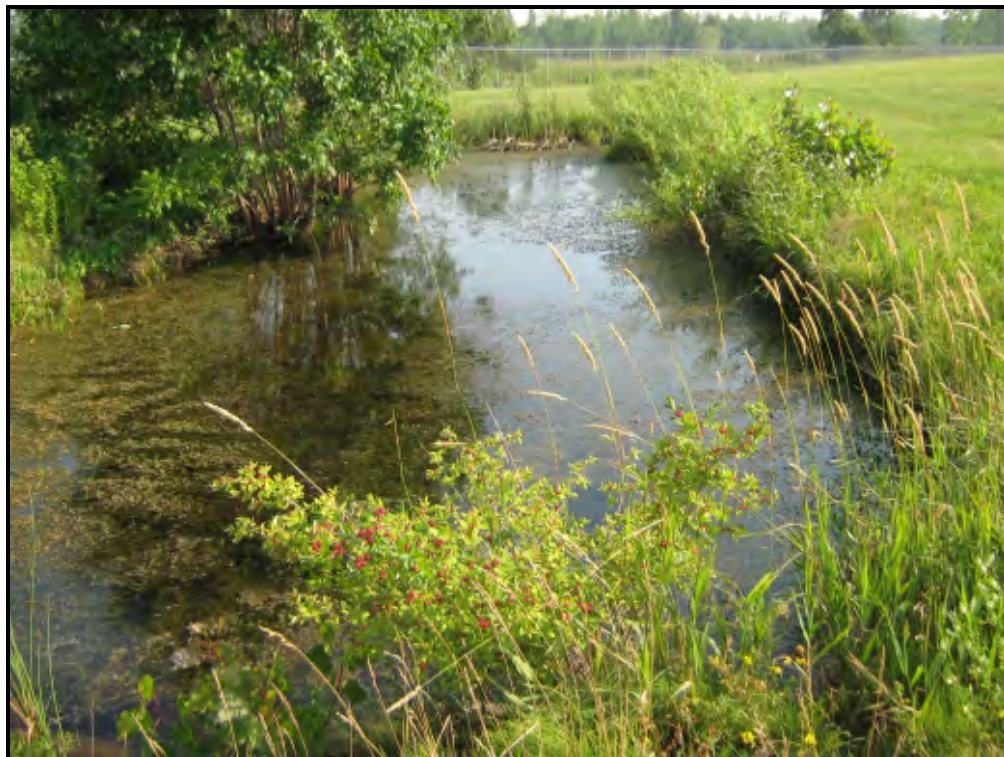
Photograph 8: Excavated channel located along the southwest edge of the wetland off the Runway 23 end. Beyond the chain link fence at the upper portion of this photograph is the checkzone of NYS Wetland LA-5. (MJ Photo 07/06/10)

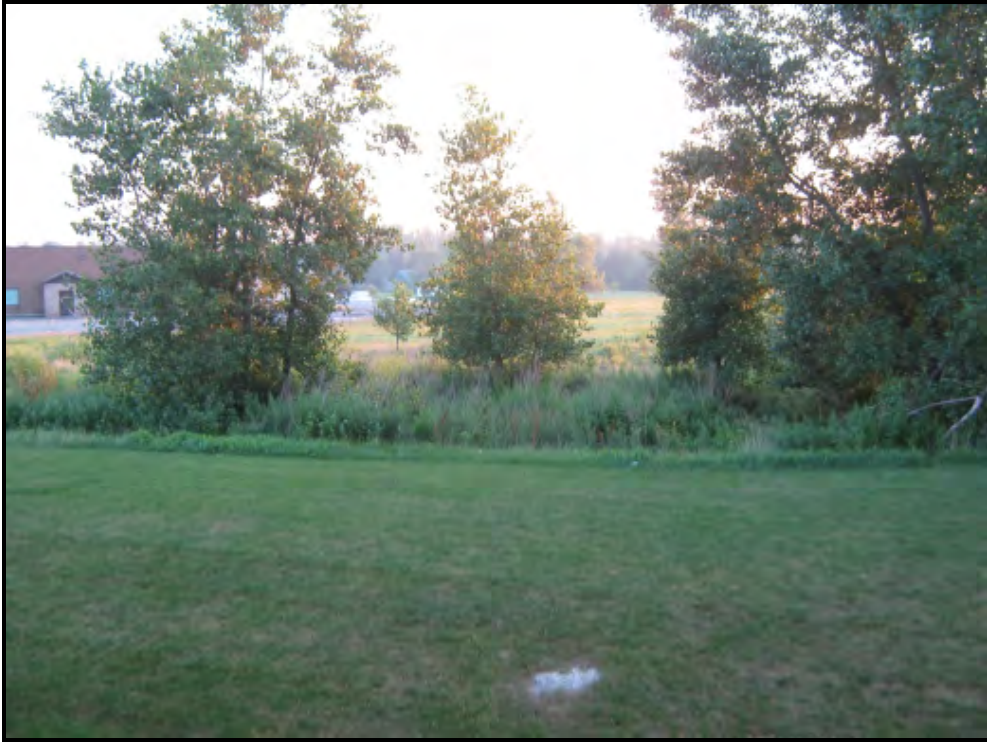
Area “E” was a long narrow strip of land located to the north of the Sleep Inn on Holtz Road. Inspection of the site concluded that it was an upland area that had been filled with construction debris. Reportedly this narrow strip of airport property was a former railroad bed, although there was no evidence of railroad bed materials, tracks or rails observed. This area was dismissed from further consideration or study as a jurisdictional wetland.

**Photograph 9: Area behind Sleep Inn off the north bound lane of Holtz Road. The area was first presumed to be a stream bed, but it was concluded that the area was a debris fill site.
(MJ Photo 07/07/10)**

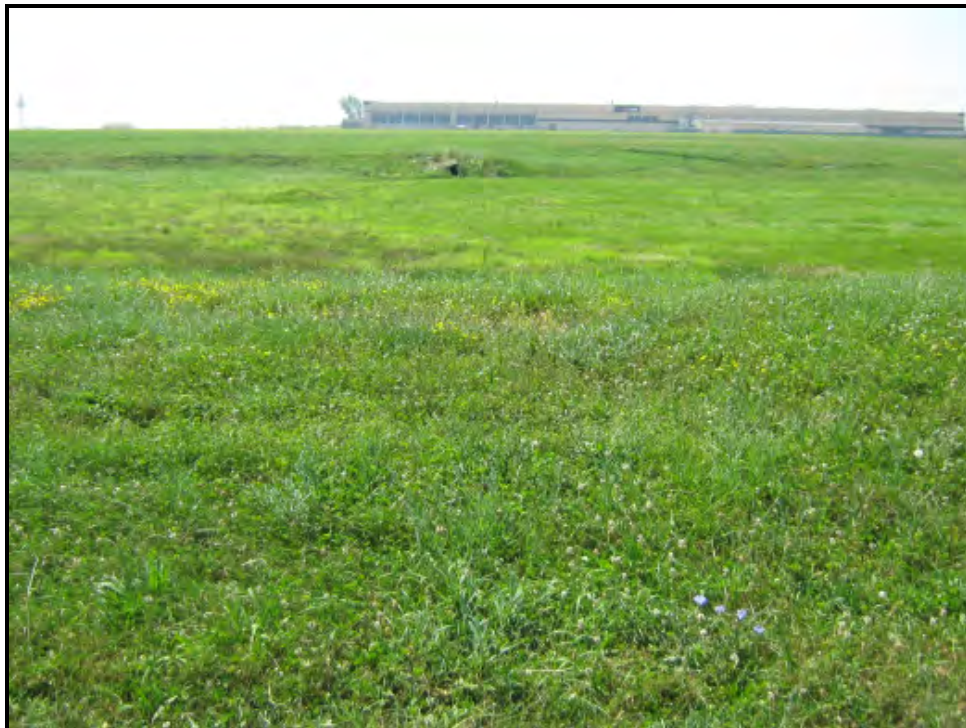
Detention “Basin A” near the Runway 14 end covers the same footprint as designed and as observed in 2000. The rectangular structure is surrounded by a slight berm with the interior having been excavated to form an infiltration bed. Only a small area of the interior of this rectangular depression exhibits wetland vegetation. The remainder is a mowed upland meadow community. This area is identified on the NWI mapping as a Palustrine emergent wetland with persistent wetland vegetation and saturated soil conditions for much of the growing season (PEM1B).

**Photograph 10: Retention Basin "A" at the Runway 14 end near Werle Drive looking to the south from the perimeter road. The area is a rectangular basin identified as wetland in the previous study.
(MJ Photo 07/07/10)**

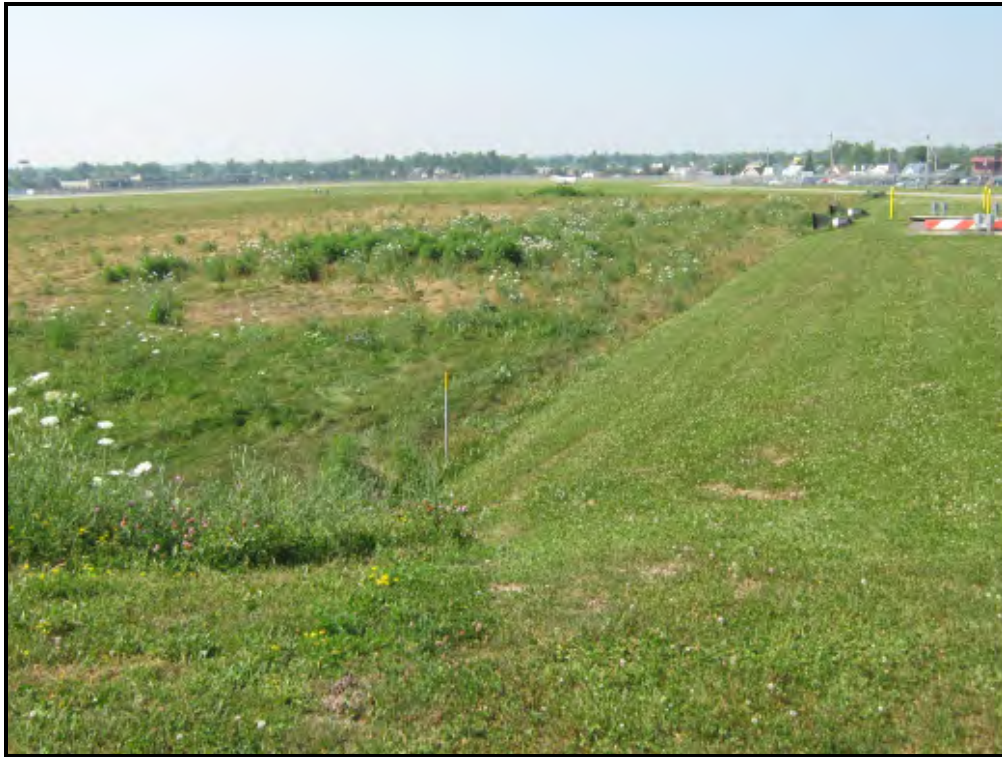
Photograph 11: BNIA's engineered underground wetland for glycol treatment. This photograph shows the #4 cell looking towards the west. (MJ Photo 07/07/10)

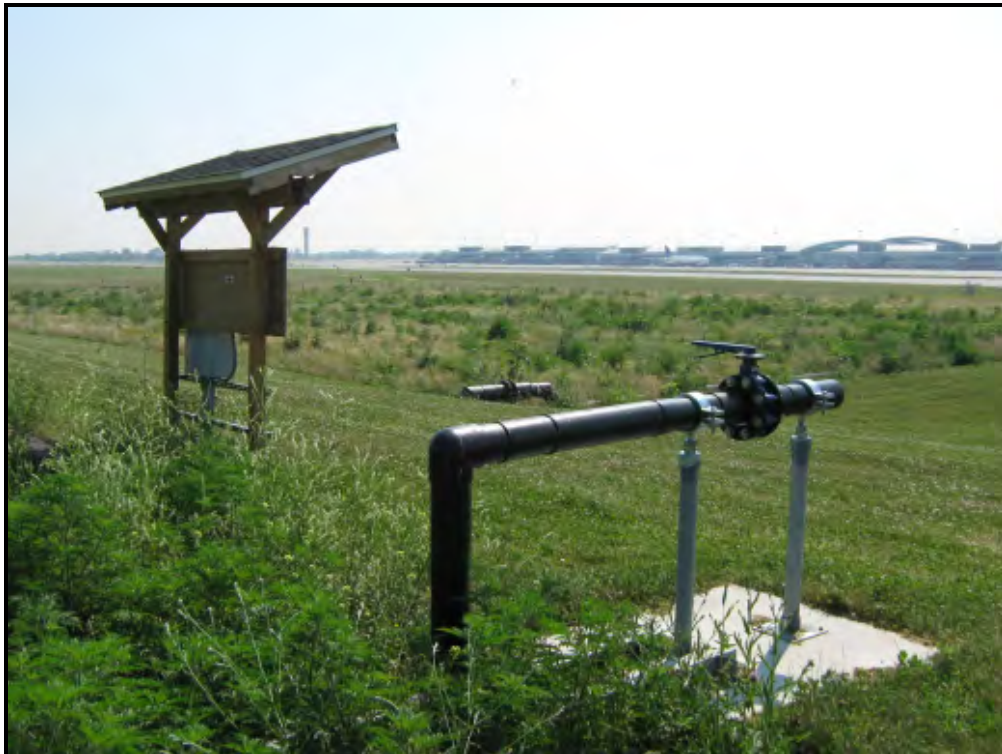
Photograph 12: BNIA's engineered underground wetland for glycol treatment. This photograph shows the #2 cell looking the eastward towards the terminal. (MJ Photo 07/07/10)

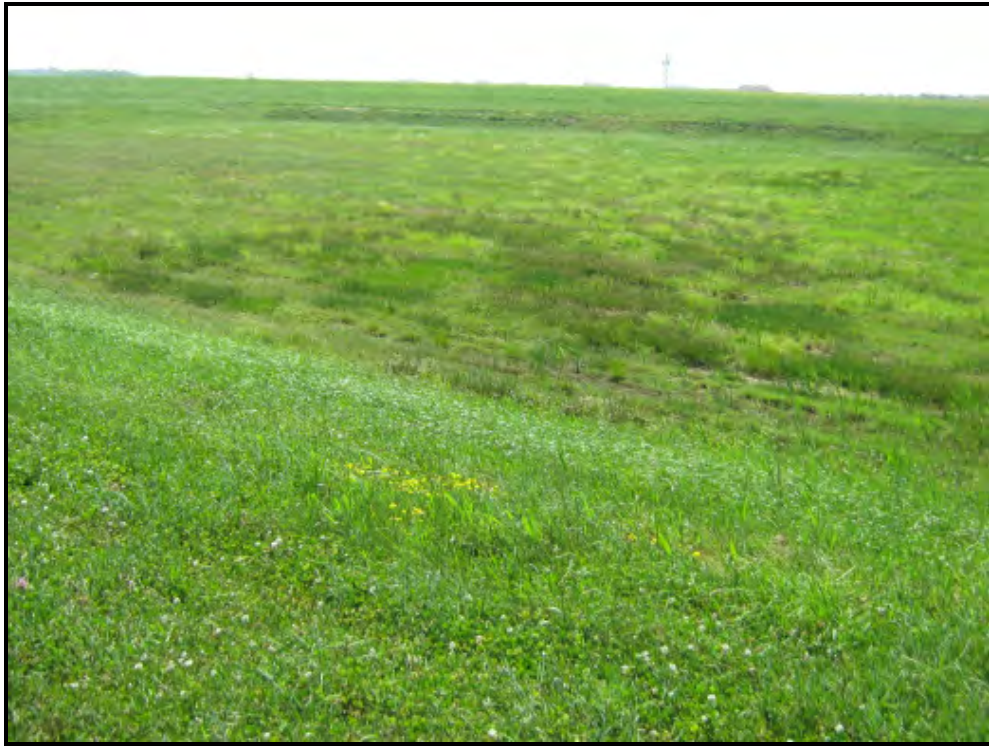
Photograph 13: Bio-remediation Basin “B” site between the fuel farm and Prior hangar #1 looking northwest from the airport perimeter road. Site is used for snow melt. (MJ Photo 07/07/10)

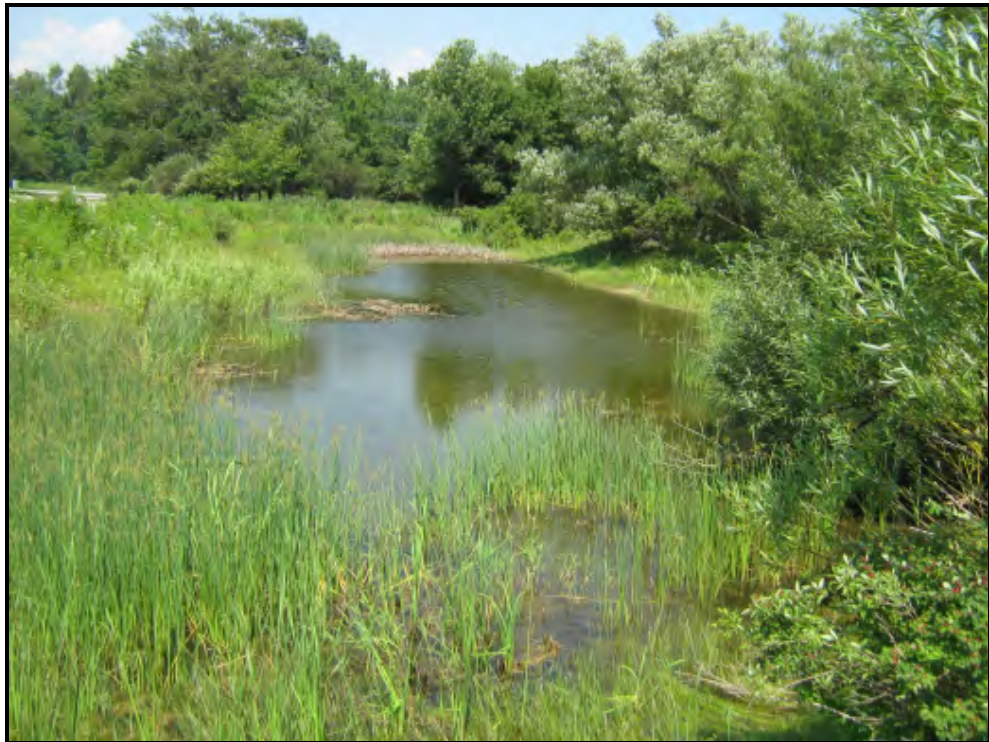
Photograph 14: Poned area outside of BNIA security fencing, but on airport property. This pond is across the perimeter road from the bio-remediation area and just east of the automated flight service station. (MJ Photo 07/07/10)

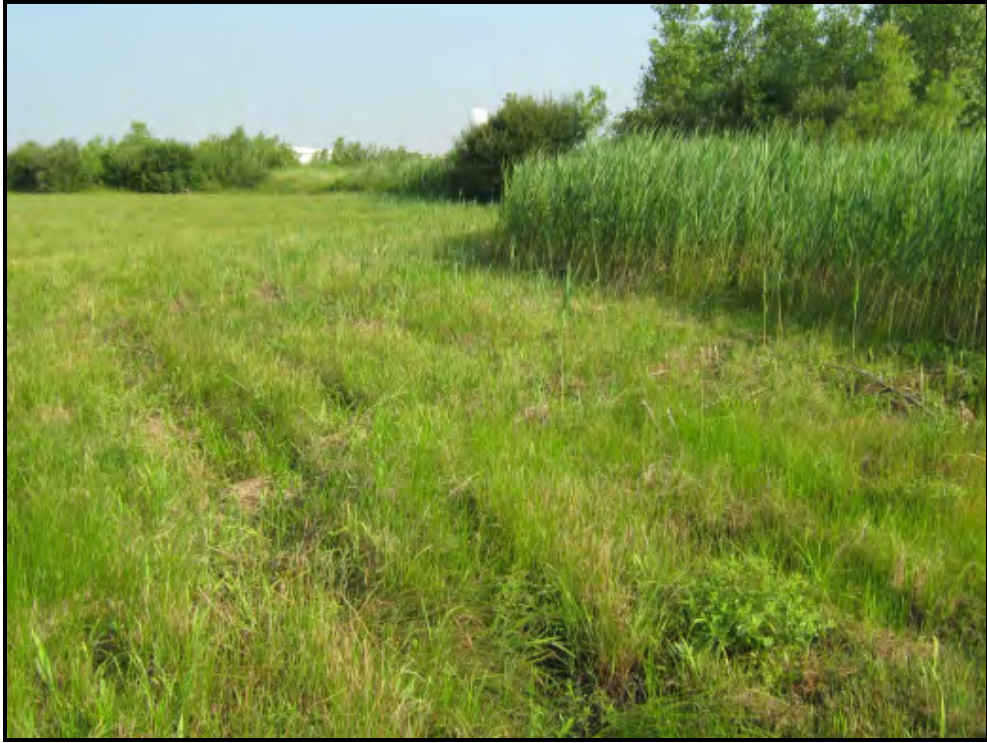
**Photograph 15: Wetland Area "F" south of the fuel farm complex looking to the south.
(MJ Photo 07/07/10)**

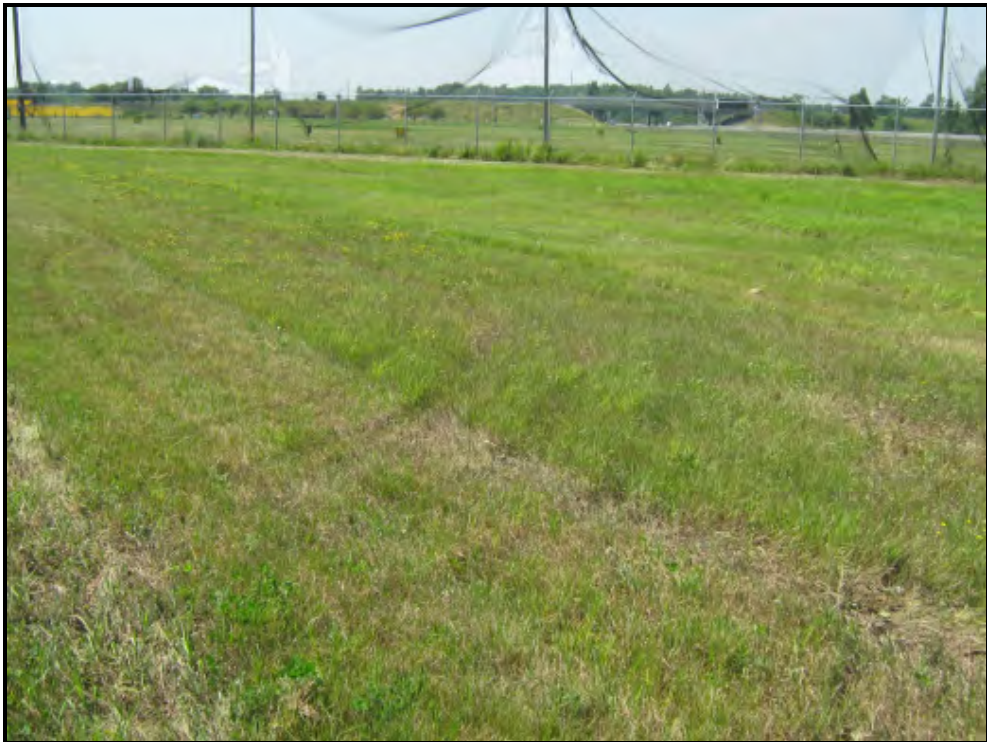
Photograph 16: Wetland area identified during the previous 2000 study located along the northwestern property edge near Runway 23 end. The site is inside BNIA security fencing, looking north onto a golf practice range. (MJ Photo 07/07/10)

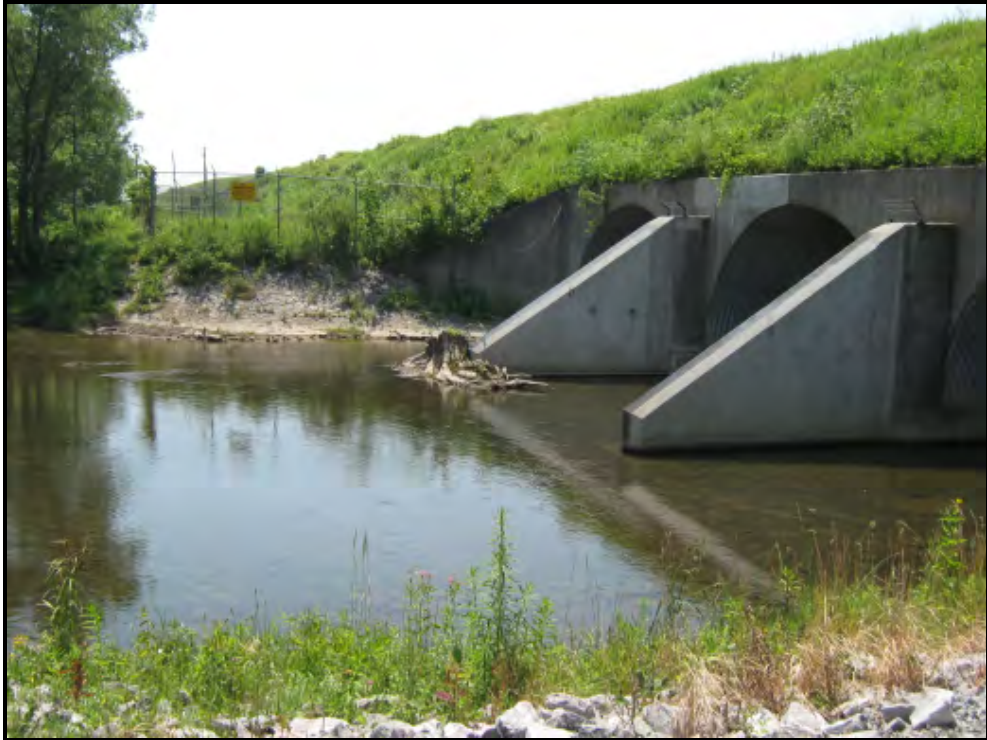
Photograph 17: Ellicott Creek upstream of Runway 23 culvert. (MJ Photo 07/07/10)
