Re: FAA
Buffalo Niagara International Airport
Airport Master Plan Update/CHEEKTOWAGA,
Erie County
10PR05280

SUBJECT: Buffalo Niagara International Airport
Wetland Verification Site Visit

BUFFALO NIAGARA INTERNATIONAL AIRPORT WETLAND PHOTO LOGUE for 2010

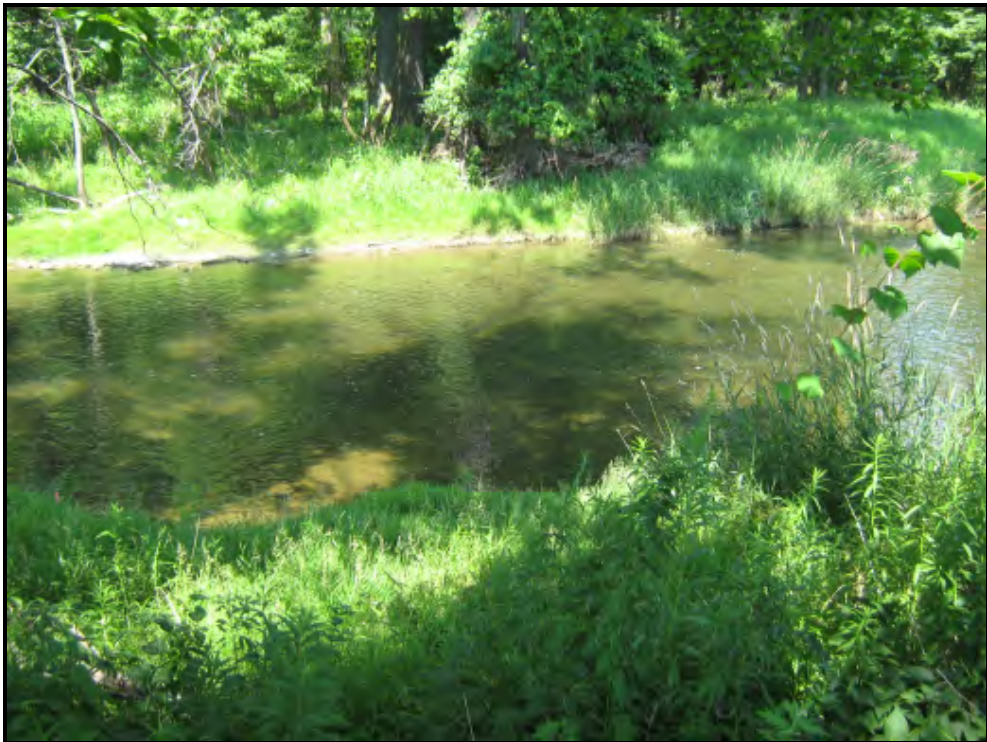
Photograph 18: Ellicott Creek downstream of Runway 23 culvert, across from the Garrison Cemetery on Aero Drive. (MJ Photo 07/07/10)
